# Post-occupancy Evaluation in Public Buildings

**Keywords: Post-Occupation Evaluation, maintenance of historical buildings, Walk-through assessment.**

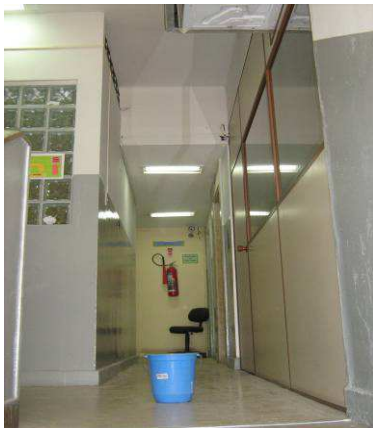
The ventilation of the building happens artificially through wall air conditioning unit. In some sectors the distribution of the air conditioner is broken due to divisions that make up the environments. It was verified the lack of drains in the devices installed on the windows, which has caused stains on the facades. There is also air conditioning units installed in the internal partitions of the rooms, facing the circulation, causing the water swearing in the hallway that leads users to the stairs of the building, causing accidents (figure 3). The staircases feature windows that contribute to cross-ventilation (figure 4).

**Figure 3 and 4: air conditioning installed and window on the stairs (Authors, 2010)**

<b>Paving</b>	Leveling the paving of the parking lot and road signs prohibiting parking vehicles on sidewalks.
<b>Ventilation</b>	Placement of drains and replacement of existing filters of air conditioners.
	Installing central air system to better distribution in the room because the height of the partitions
<b>Facades</b>	Applying sealer and paint the facades general.
<b>Layout</b>	Review the layout as the design of internal circulations of rooms offices.
	Standardization of securities, installation of cabinets and sliding files.
<b>Facilities</b>	Installing taken near the equipment, changes in positioning of switches.
	Installation of pull boxes and raceways for conducting wireless network and equipment in general.
	Withdrawal of sockets and extensions exposed to the action of rain on the balconies.
<b>Lighting</b>	Replacing bulbs in offices that are flickering to prevent visual discomfort.
	Installation and exchange of signs that indicate the sectors and rooms according to the current usage.

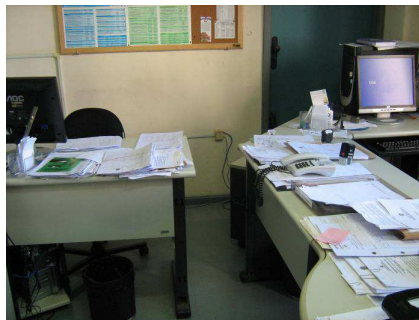
We observed the following problems: lack of standardization of the mobile office rooms and circulation close, depending on the arrangement of the furniture, causing difficulty in the flow of employees (figure 5), especially those who have limited mobility. In some sectors were installed files sliders that favor the handling of documents.

**Figure 5: circulation narrow (Authors, 2010)**
