# Façade Assessment Procedure for the Evaluation of Durability of Existing Buildings

The method has a direct experimental application within the project “Città Studi: Sustainable Campus”, which has the aim to transform the university quarter in Milan into an exemplar campus with respect to life quality and environmental sustainability. In particular the paper will report about the recovery-requalification of existing buildings of Politecnico di Milano at Leonardo Campus, which are nowadays under investigation/study through visual inspections, imaging diagnostic, and especially, IR Thermography. The case study deals with both the issue of repairing and increasing energy efficiency, considering durability and management of buildings, and the cultural issue of preserving masterpieces of the contemporary architecture, since many of the buildings under investigation have the famous architect Giò Ponti as author.

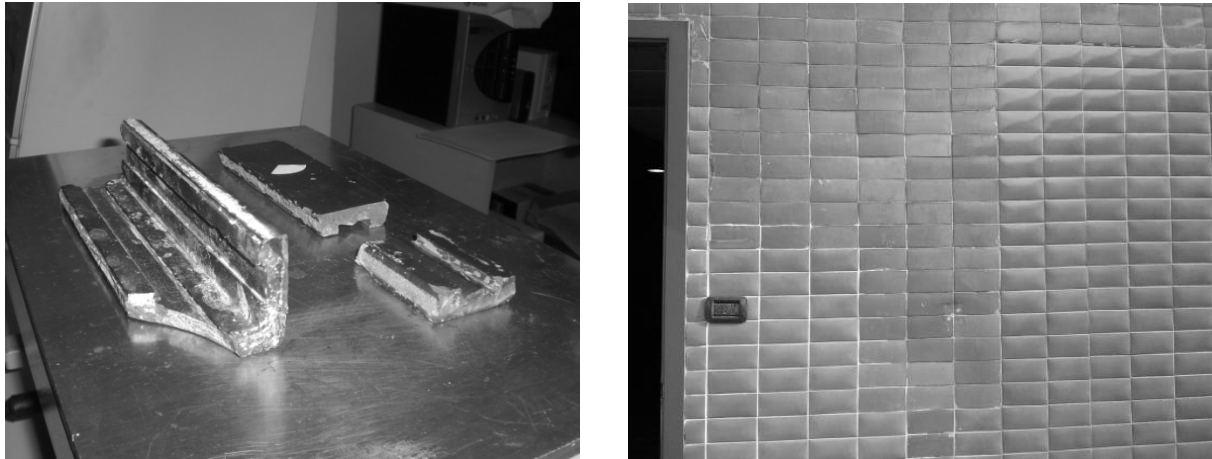
**Figure 1: a. Building 12 – tiles details, b. Building 14 – original and new tiles**

Building 14 “La Nave” – presents grey clinker tiles placed on a finishing of mortar (2,5 cm thick). On the façades it’s possible to recognize two different types of tiles: Giò Ponti original tiles and new ones, after maintenance interventions. The new series of tiles have flat and smooth surface while the original has rounded polyhedral surface (*fig. 1.b*).

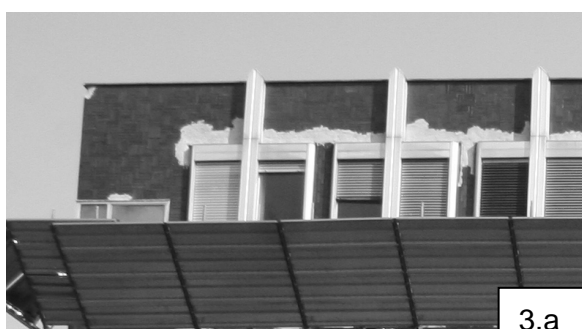
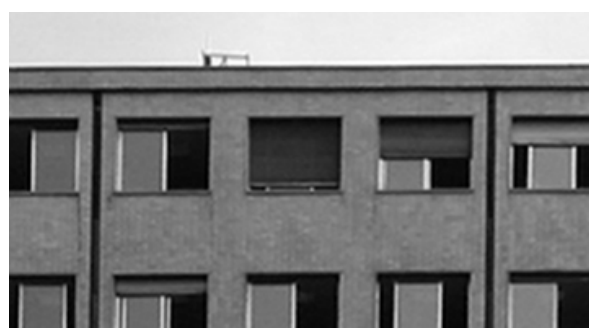
**Figure 3: a. Building 12, South façade; b. Building 14 “La Nave” North façade**

These two case studies have been presented in order to show the application of the methodology and to study the effects of the different orientation and therefore solar exposition of the façades in the thermographic analysis. In the picture on the left it's possible to notice areas interested by missing tiles and it's visible the presence of mortar on detached tiles above the window. The picture on the right represents a portion of the North façade of building “La Nave” where the tiles look intact by visual examination. From the picture it's possible to see moisture stains caused by percolation below the window sills.

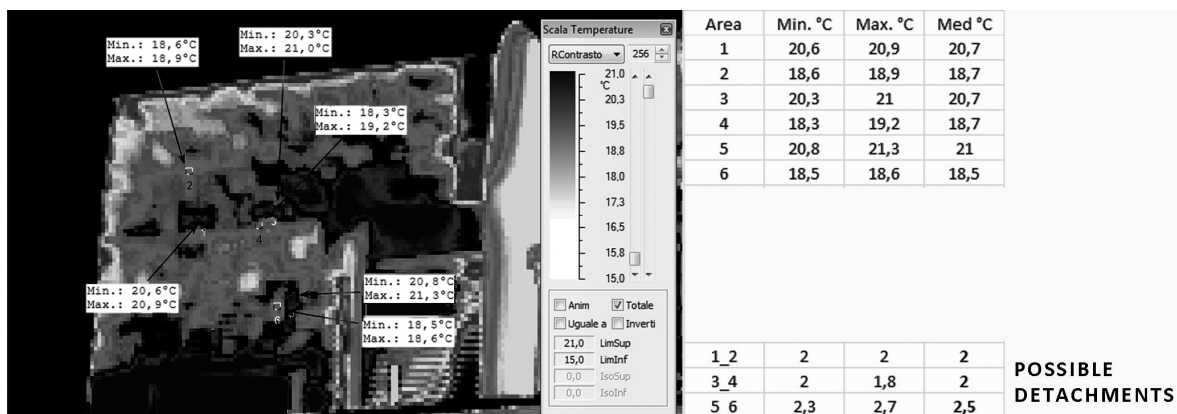
The following pictures show the analysis of the thermogram, in which the characteristic gradient of probable detachment has been identified through the selection of small adjacent areas having different temperatures. In particular for the Building 12 a gradient around 2°C has been evaluated as characteristic of the pathology while in the case of “La Nave” it is equal to 1°C. This difference is due to the orientation of the façade under study which in the case of North side receive less solar irradiation.

**Figure 4: Building 12, South façade, 5<sup>th</sup> floor – characteristic thermal gradient identification**

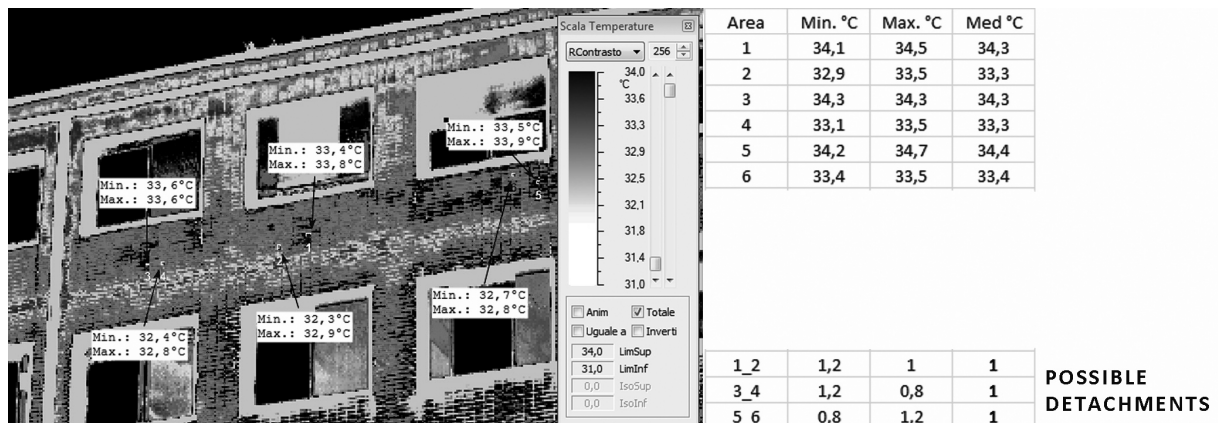
**Figure 5: Building 14 North façade, 6<sup>th</sup> floor – characteristic thermal gradient identification**

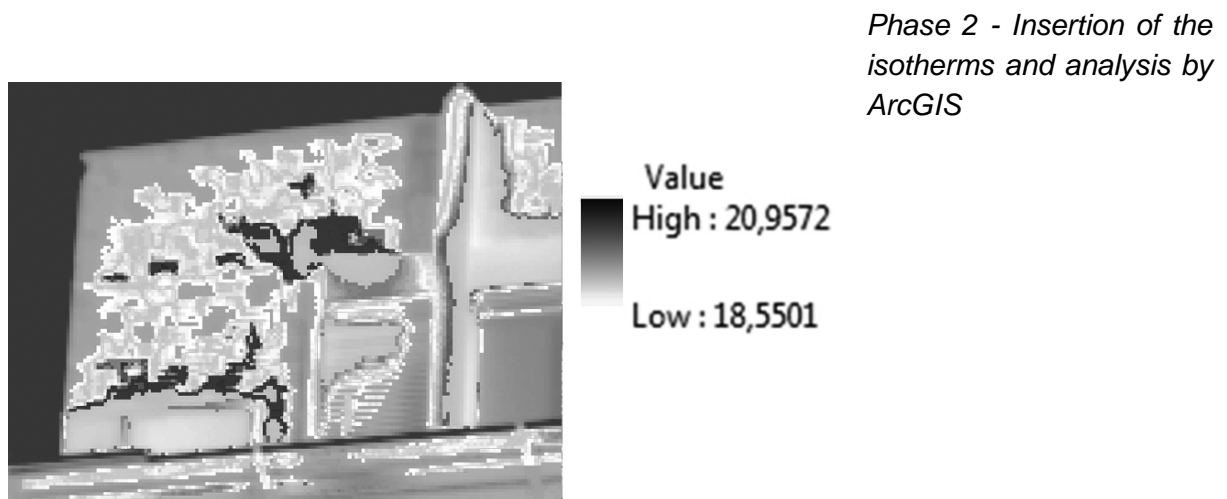
**Figure 6: Building 12, South façade, 5<sup>th</sup> floor – areas with possible detachments (in black) and adherent ones (in white)**

The temperature difference between the surface with possible detachment (in black) and the adherent ones (in white) is respectively 2°C for Building 12 and 1°C for “La Nave”. The areas characterized by higher temperatures but affected by gaps or by the presence of different materials are to be identified through a rigorous comparison with the picture of the visible

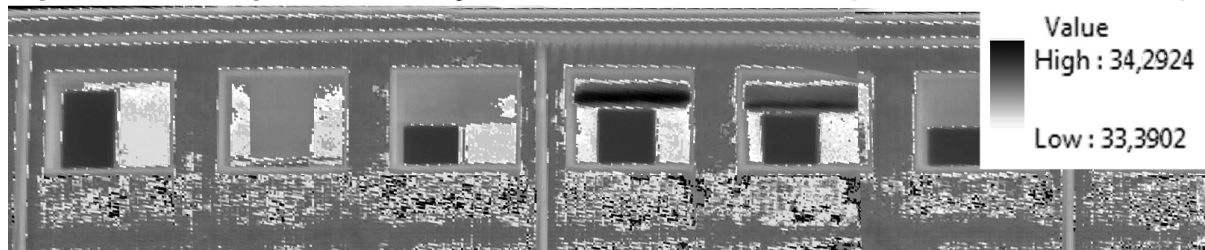
**Figure 7: Building 14 North façade, 6<sup>th</sup> floor – areas with possible detachments (in black) and adherent ones (in white)**

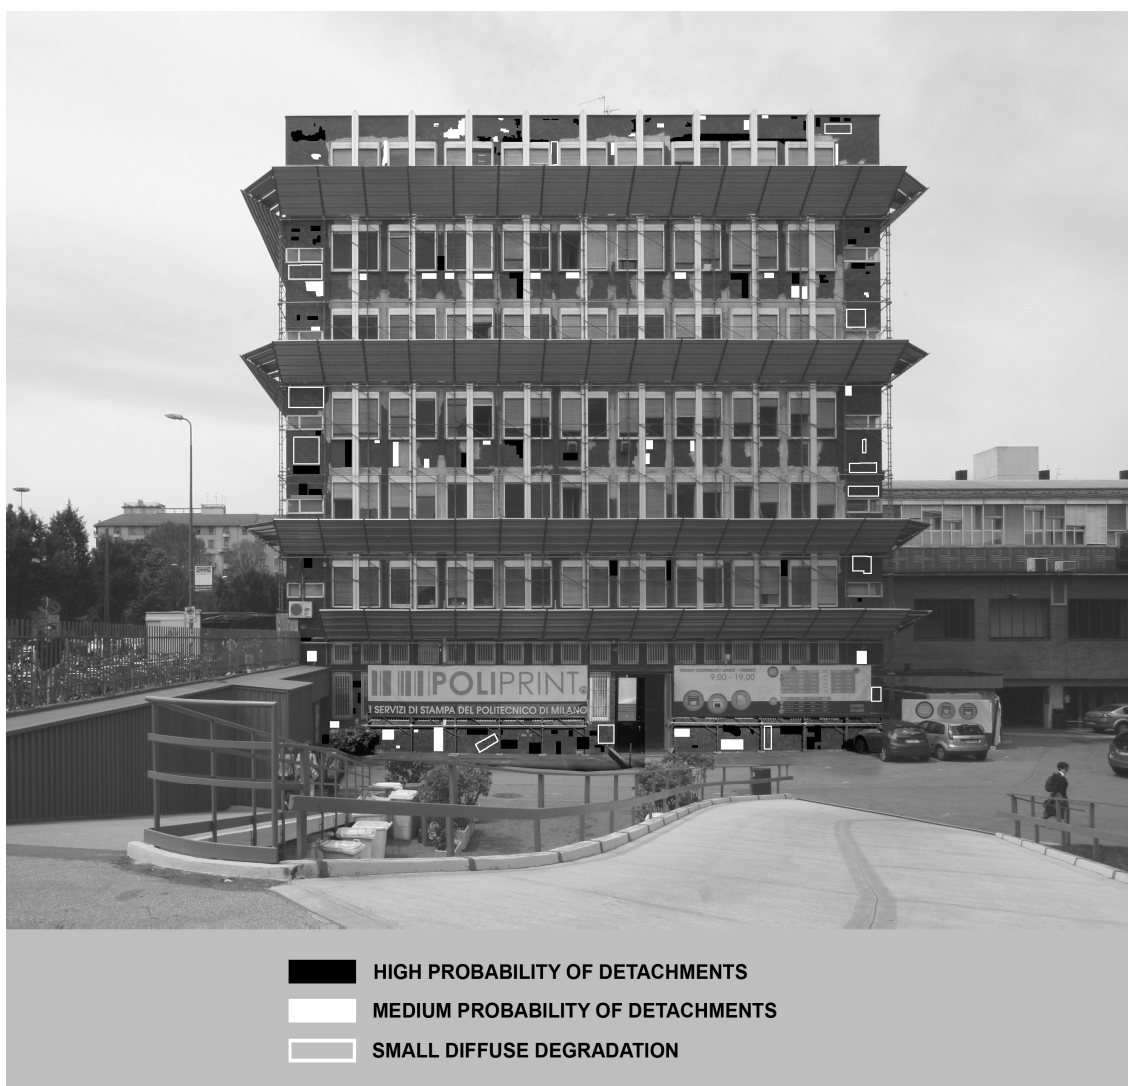
As example, the following figure shows the outcomes of the process through the map of the possible tiles detachments as regard the East façade of Building 12, for which has been evaluated a characteristic gradient around 3°C, due to high solar irradiation. The areas in which the thermal anomalies are representative of detachments are represented with boxes: the areas with higher probability of detachment (80%) are highlighted in black, in white the ones with medium probability (50%). The areas with white border indicate probable

detachments of single tiles diffuse along a certain surface.

**Figure 8: Example of application: Building 12 East façade, possible detachments of cladding tiles**
