# Seismic safety of places of worship in Italy's Gran Sasso and Monti della Laga National Park

Aurelio Petracca<sup>1</sup>, Carmela Morisi<sup>2</sup>, Giandomenico Cifani<sup>3</sup>, Giovanni Cialone<sup>4</sup>

## Abstract title

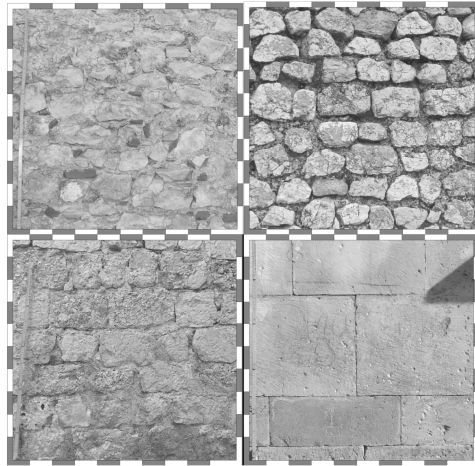
The breakdown of the different types (table 2) shows that most of the sample belongs to type A, whilst there are no examples of type D. Type E often regards the façade, this being built with large blocks of limestone that are carefully squared in order to produce a building of striking architectural impact.

**Figure 6. Sample of masonry types: starting from top left A, B, C, E**

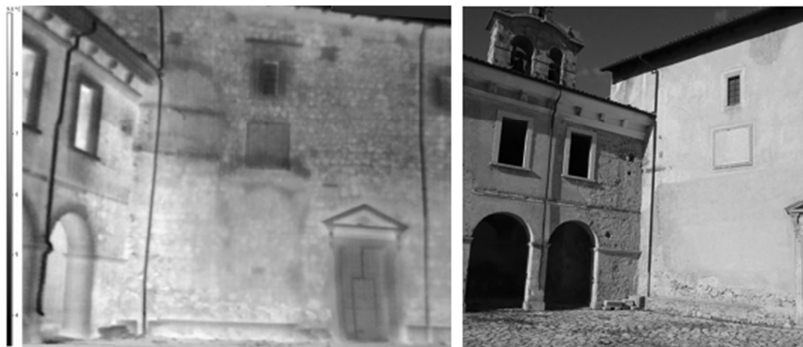
Thermal imaging was carried out on some of the buildings in order to assess, without touching plastered surfaces, the elements required for characterization of structural members such as: the vertical arrangement of the masonry structure, presence of gaps/irregularities and substructures, vault type, degree of instability and details of the cracks. Thermal imaging was carried out by a workgroup led by Prof. Ermanno Grinzato. The thermal images produced enabled direct verification of the quality of the information that can be obtained (figures 7, 8).

**Figure 7. Santa Maria di Valleverde church in Barisciano, thermograph and photo**

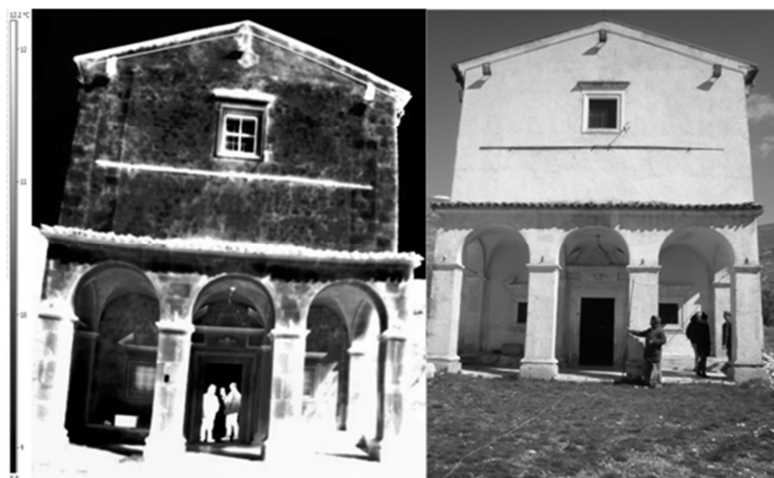
**Figure 8. Madonna del Lago church in Santo Stefano di Sessanio, thermograph and photo**

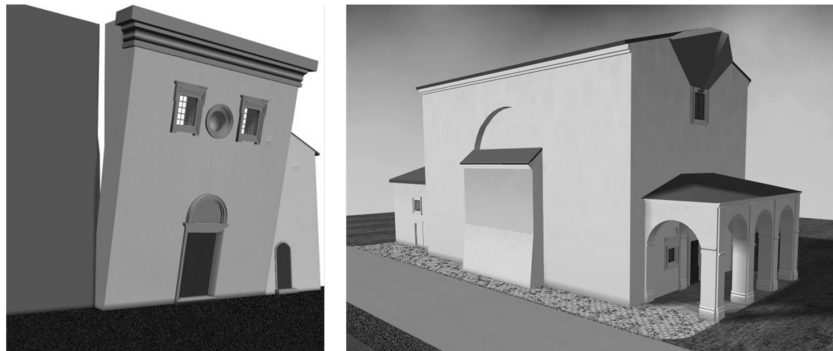
The aim of the qualitative analysis is to highlight the mechanisms whose presence and activity are revealed by some degree of damage for which they are directly responsible and identify the mechanisms most likely (figure 10) to be activated in the future based on observation of the churches' structural features, type and vulnerability attributable to specific characteristics or else statistically common. Having ascertained the mechanisms already activated or likely to be so, linear kinematic analysis was carried out in accordance with technical standards.

**Figure 10. On the left the San Francesco church in Carapelle Calvisio (AQ), façade overturning mechanism; on the right the Madonna del Lago church in S. Stefano di Sessanio, tympantum overturning mechanism with formation of oblique hinges.**

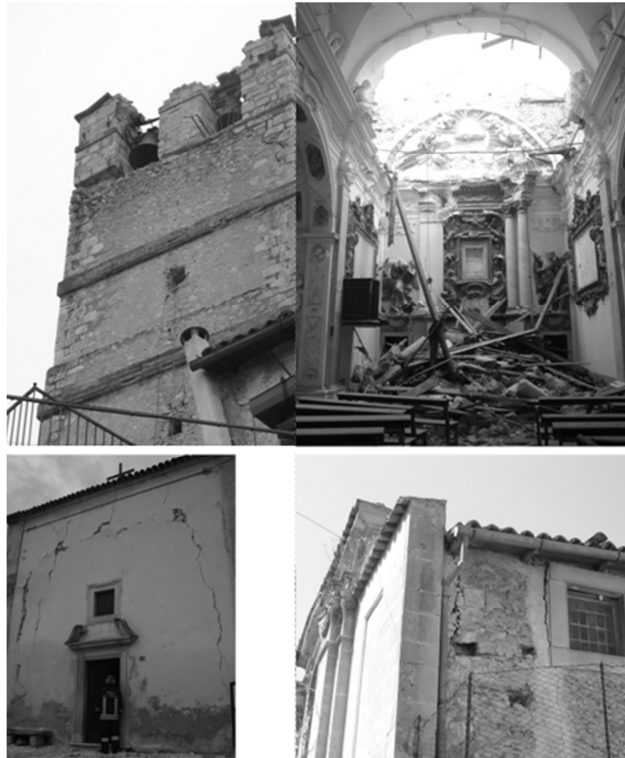
The churches studied have suffered varying amounts of damage, in some cases severe (figure 11).

**Figure 11. Example of damage suffered by the churches: starting from top left the churches of Santa Maria e San Vittorino (Carapelle Calvisio), San Marco Evangelista (Castel del Monte), Madonna del Rosario and Santa Maria del Carmine (Barisciano)**
