Thermo-hygrometric and physical-mechanical pathologies of the steel flat roofs: the case of a large industrial plant in Tito (Potenza, Italy).

Thermo-hygrometric and physical-mechanical pathologies of the steel flat roofs - Abstract

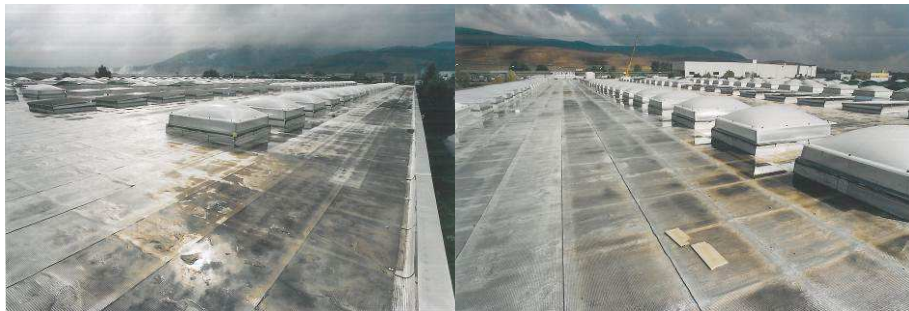
At the end of 2004-2005 winter, the flat roof of the plant showed extended the dripping water, for this reasons in some areas had been necessary to set, hanging from the ceiling, PVC sheets, for protecting the equipment below. The dripping water appeared not ever in the same points, even if in some places occurred more frequently. Considering the manufacturing type done in the plant, and especially the need of controlled humidity ratio, the occurring of unexpected and sudden dripping water, in random places, led to unacceptable risks of damages and malfunctions, with heavy economic consequences, since a signal control cabinet is worth many hundreds thousands euro. On the other hand, already watching from the exterior (see Pictures 4-8), the roof of the plant after a rain was like a quagmire, stained by layers of dust and soil carry by the wind, by the areas in which the clear lack of gradient not allowed to the water of duly flowing, and the upper layer of aluminium embossed facing (third of the layers of this type superposed), showed systematic blistering (Picture n. 9), mark of the presence below of vapour and/or water. Indeed, pressing that blisters, we caused the expulsion of water, if we maked or if there was a crack in the aluminium facing and/or in the prefabricated membrane.

Pictures 4 and 5: After a rainfall, the covering presented itself as one immense quagmire

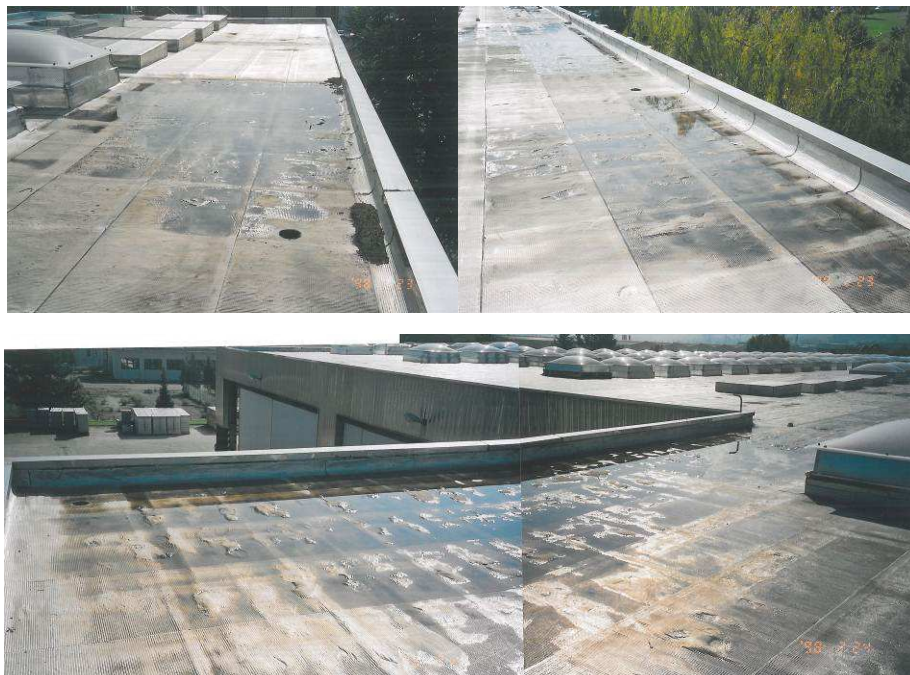
Pictures 6, 7 and 8: The water was unable to reach downpours, owing to deformation of the covering plane, and to limited slopes

The slope conferred on the roof, with ratio of 0,5%, has proved quite insufficient and, in some area, even absent. The high slenderness of the steel girders of the deck did *fluage* deformations resulted to be equal or more, compared to the slope of the roof (design camber has been the maximum preview by Italian Regulations, 1/200, and then 3 cm on 6,00 m, exactly the same of the slope 0,5% on 6,00m). Therefore, little rise at junctions, caused by crossed orientation of the sheets, has been sufficient to lead to formation of so many little quagmire; while snow load, when present, has buckled deck, obstructing due water drainage, and favoring the inside penetration [CASH 2003, pag.34-35; 39-40].

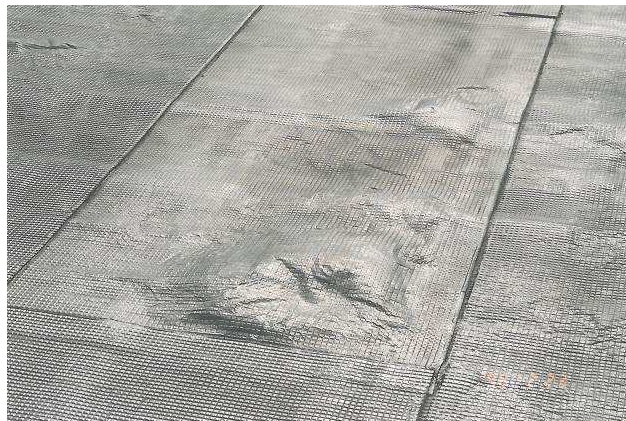
The first cause of dripping water has been identified in the absence of a continuous vapour barrier below the insulation. It must be underlined that normally we think that corrugated steel sheets constitute a vapour barrier, and therefore also on most updated manuals, which are aimed at defining the “*compliant solutions*” and “*the rules of art*” concerning waterproofing, we invent drawings which show “*as model*” steel flat roofs identical to that of this case study; without thinking that, depending on corrugated sheet element selected, every 76 o 100 cm in cross way, and every 330 o 660 cm in longitudinal way, and all facades perimeter long, and all joints with bases of skylights long, the corrugated steel sheets book off, and simply they approach or they overlap to the adjoining sheets , normally (and also in that case) without carry out any vapour sealing, with self-sticking band or liquid sealants, or foams especially formulated for this purpose. In addition, screws for fastening the insulation, anti-wind uplift, make they too thousands of holes in the sheets, and make possible the vapour passing. The result is that vapour coming from internal space reaches the insulation layer, and in it reaches dew point and condenses. This water in liquid state cannot be evacuated towards the exterior trough evaporation (due to the great resistance to vapour diffusion of two prefabricated membranes (later on got four) and their aluminium facings, and due to the total absence of roof vents), after having saturate the insulation, highly decreasing his insulating qualities, dripped in the hollows of the corrugated steel sheets, flowed along them, following their slope, and went out dropping when invented a connection between elements of metal sheets, or a screed hole, or a hook for electric device or false ceiling.

Picture 9: Blistering pathologically large and wide-spread

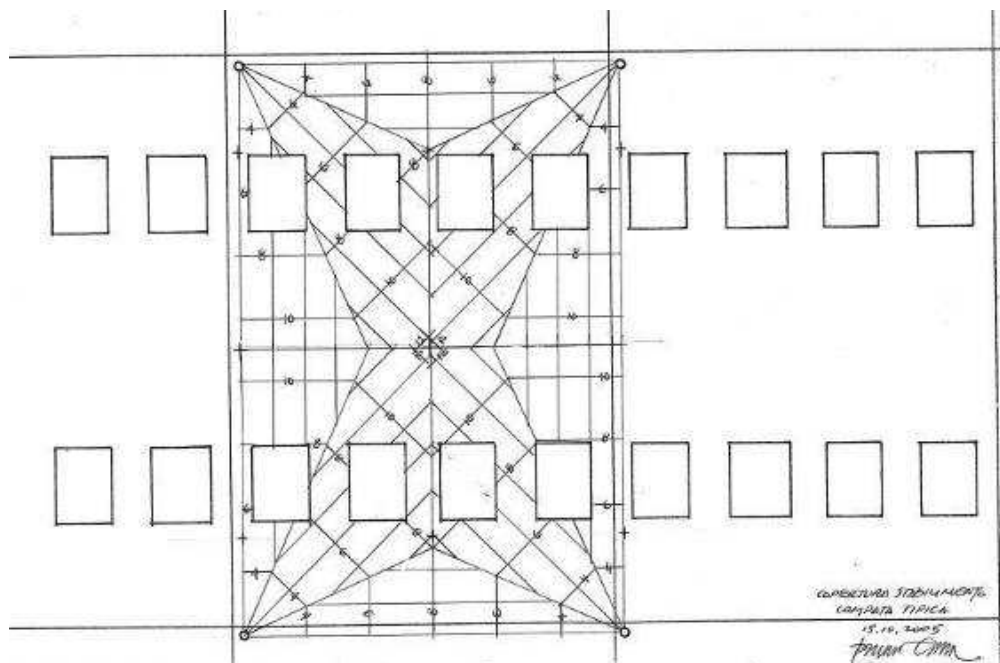
Figure 3: Plan of the typical span of the industrial plant (18,00 x 12,00 m), with EPS panels, used to create slopes. Numbers show panel thickness

Structural design of the building was to reserve 50 Kg/m² for ballasting with gravel waterproofing and insulation, but gravel has never been put in place. We preferred to conserve this charge reserve for making use of that for dry setting a ventilated raised floor, to realize a sunscreen. Therefore has been obliged the choice of carrying out slopes (of the further ratio of 1,5%) with EPS pre-shaped panels, 1,00 x 2,00 m, and thickness from 2,00 cm minimum to 12,00 cm maximum on the plant roofing, and from 2,00 cm to 24,00 cm on the offices roofing (Fig. 3).

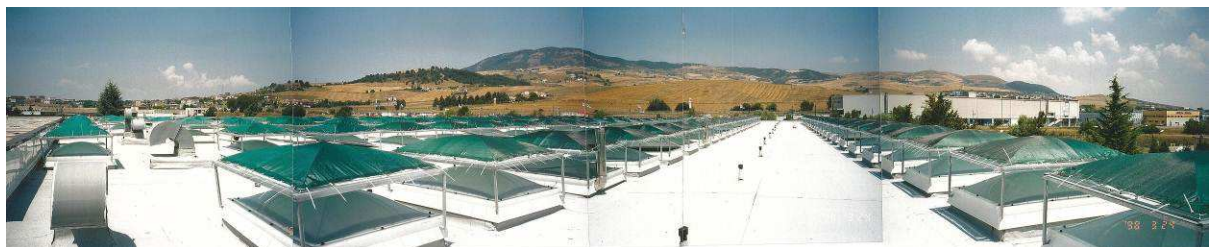
The basis of the skylights, made in steel galvanized brake formed sheets, completely lacked of insulation (with winter design temperature of -3 °C), and therefore water drippings in their correspondence had to ascribe, at least in part, to the condensations at their perimeter. Due to the presence of n. 208 skylights, every of 1,80 x 2,40 m, distributed in uniform ratio upon all productive plant surface, problem was certainly not secondary.

Picture 15: Then the insulations on the skylight and the flashings for protection and sunshades bases were assembled

opaque, have been replaced with moulded elements in polymetil-metylacril, with air space anti-condensation, transmittance of 2,27 W/(m²K). Bases are been raised and full insulate from the exterior, removing thermal bridges (Picture 15). They are now provided of a structure that in summer has a tent made by a shading net, that in winter is removable and stackable.
