Analysis of seismic vulnerability of structures and estimating the vulnerability of technological systems of the hospitals in the Molise Region (Italy)

3. Hospital "Vietri" of Larino example

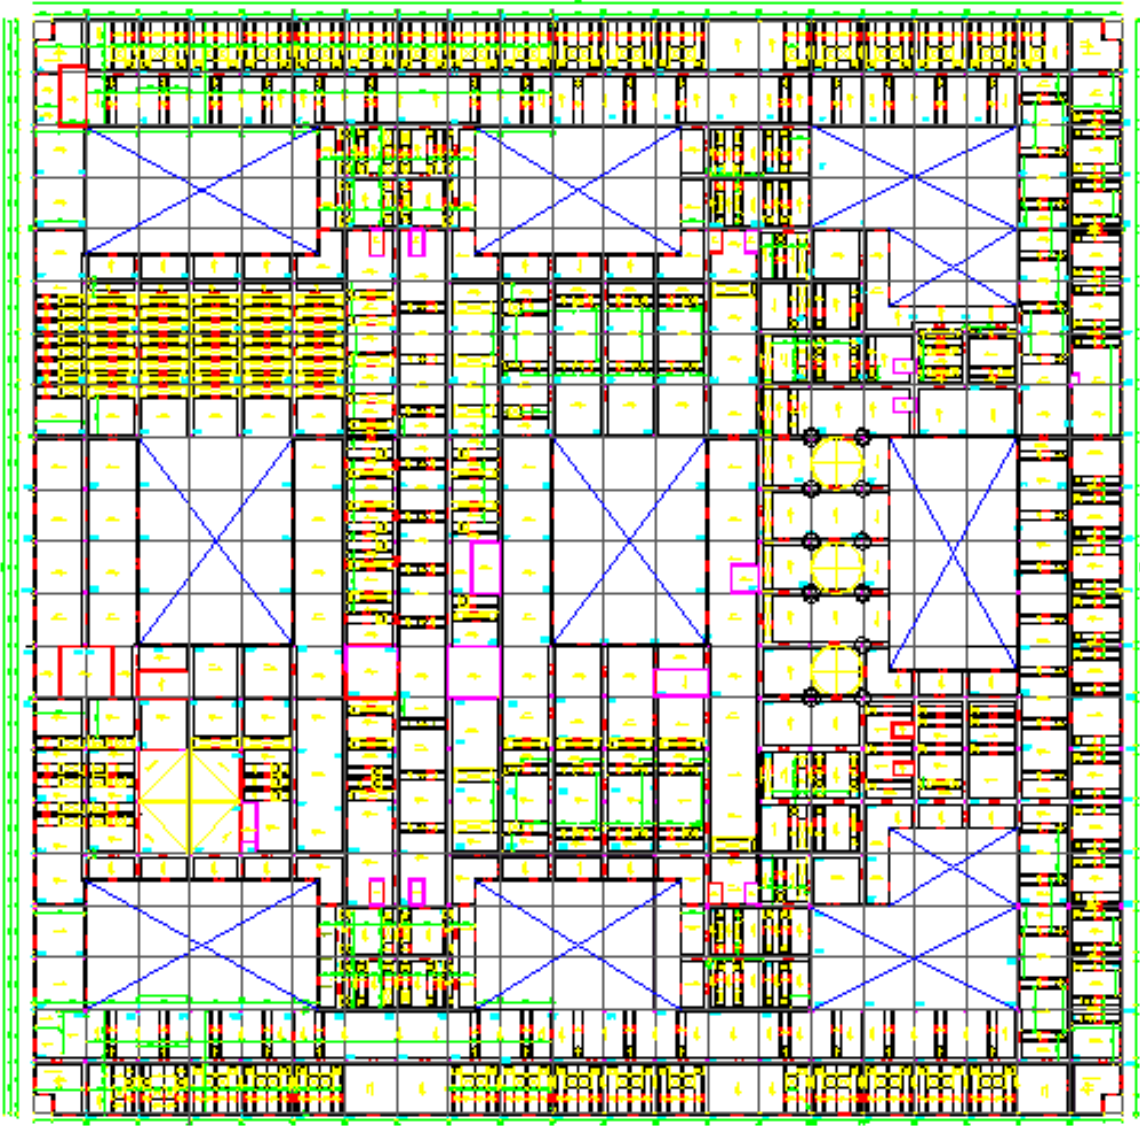
Figure 1: Map of the last level

problems encountered: the existence of a plan to 'stilts' in height up to 14 m; presence of pillars in large slenderness (height up to 14 m); irregularities in the distribution of stiffness in plan due to the presence at the first level of pillars with strong difference in height between the upstream and downstream and of baffles in an eccentric position; presence of joints (for most 'closed' by inclusion of works of solidification) arranged in an irregular manner; presence of overhangs large (up to 3.5 m); deformation of the decks in their plan due to the large size of the building plan; septa equipped with armor of small diameter and large pitch; poor shear strength of the structural elements, in particular the vertical ones; the presence of a long corridor with walls made of reinforced concrete supported by beams.
