Performance of Seismically Isolated Buildings at March 11, 2011, Tohoku Earthquake

The State of the Art of Seismically Isolated Buildings in Japan

2.1 SI building (A)

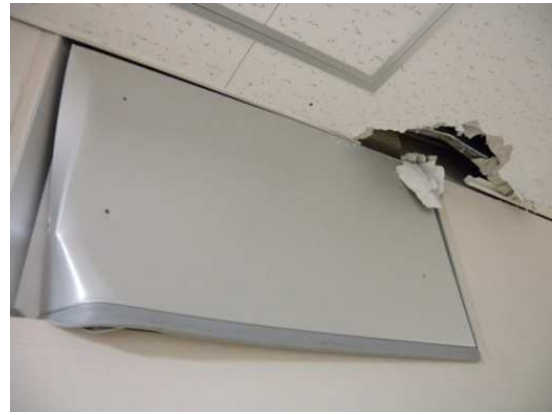
The SI building (A) is a reinforced concrete office building with 9-story super-structure and 2-story basement, located in Miyagino-ward in Sendai-city (Figure 3-(a)). The building was retrofitted by using base isolation technique putting isolation devices on the top of columns in B1F. The floor plan has the 26.4 m × 54 m rectangular shape and 44 high-damping rubber bearings (HRBs) are installed. At 2011 Tohoku Earthquake, no furniture was turned over and no structural damage was observed. However, some damage was observed at the cover-panels of fire protection and the expansion joints near the boundary between isolated and non-isolated floors (Figure 3-(b)). It seems that parts of expansion joints were not well operated due to the large displacement of SI floor during earthquake. This building has accelerometers at B2F, 1F and 9F (top floor). Also, there is an accelerometer installed by JMA in the basement of an adjacent building. The maximum acceleration values of these accelerometers at the main shock of 2011 Tohoku Earthquake are listed in Table 2.

(b) Damage to the cover panel

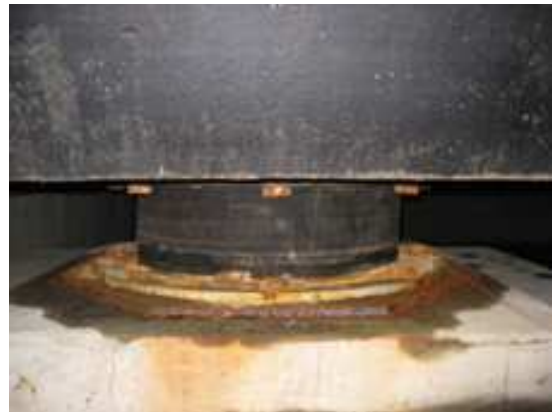
The SI building (B) is a one-story steel warehouse constructed in 1996, located in Miyaginoward in Sendai-city (Figure 4-(a)). The building height is 30 m. There are 20 HRBs (with diameter 850 mm) and 4 HRBs (with diameter 800 mm) arranged in the basement with 51.6 m × 31.7 m rectangular shape. Since the building is located near the Sendai-Shiogama bay, Tsunami reached the building and the SI floor was submerged under water. Since this warehouse is a freezer, water entered in the freezer space was frozen after the earthquake. Also it took 16 days to remove the water from the SI floor. No damage to the building was observed. Also, from visual inspection, there was no harmful scratch or inflation of the rubber of HRB, however, severe rust was observed at the steel plates and bolts (Figure 4-(b)).

(b) Damage to the cover panel

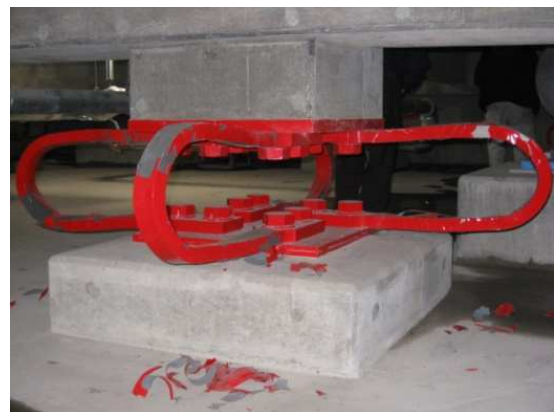
The SI building (C) is a 14-story reinforced concrete building used for condominium, located in Miyagino-ward in Sendai-city (Figure 5-(a)). The building has the U-shape plan and the corners of the building are separated by expansion joints. There are 24 NRBs, 8 Lead dampers, and 13 U-shape steel dampers installed in the SI floor. According to the owner of the building, no furniture was turned over and no structural damage was observed inside of rooms after the earthquake. Also no damage was found to NRBs by visual inspection; however, paint of U-shape dampers was peeled off (Figure 5-(b)) and many cracks were found on Lead dampers (Figure 5-(c)).

(b) U-shape steel damper

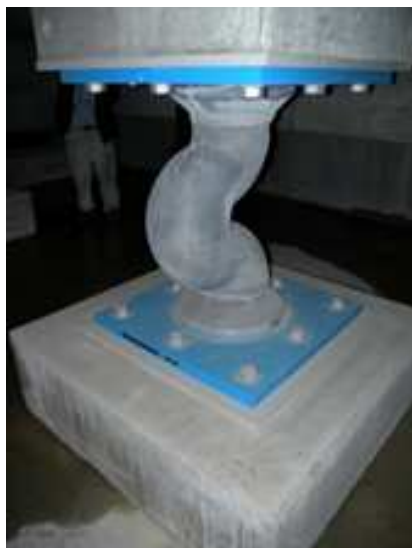
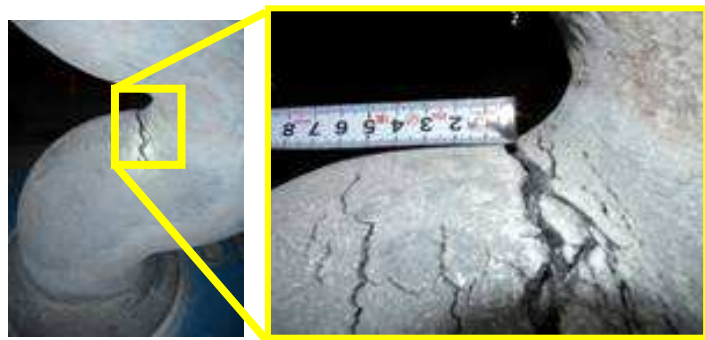
(c) Lead damper and crack on the surface

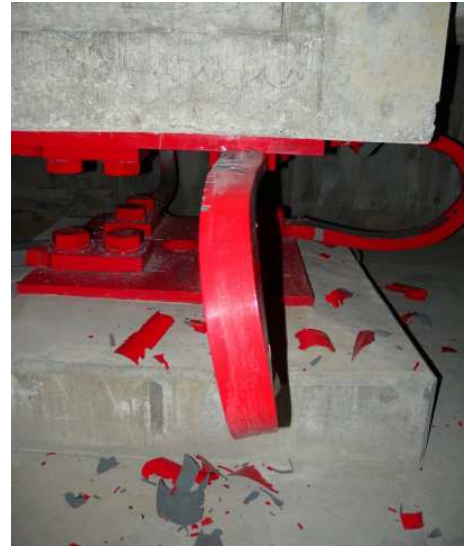
bearings (LRB) (6 with diameter 650 mm and 28 with diameter 700 mm) , 11 elastic-sliding bearings (6 with diameter 500 mm and 5 with diameter 600 mm), and 8 U-shape steel dampers. a) According to the person in charge of the building, no furniture was turned over and no structural damage was observed. However, because of the movement of SI floor during earthquake, the bolts of steel dampers became loose and the paint on the dampers was peeled off widely. Also a large amount of residual deformation of steel was remained (Figure 6-(b)).

(b) Deformation of steel damper

Also, it was confirmed that some steel dampers experienced plastic deformation during the earthquake; however, it is unclear how much of plastic deformation capacity is left. Therefore, it is required to install a sensor in seismically isolated floor to measure the amount of deformation.

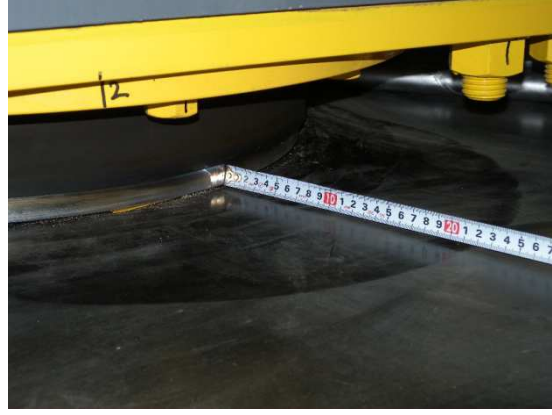
The following SI devices are installed in the basement: 6 natural rubber bearings (NRB) with diameter 1000 mm, 16 laminated rubber bearings with diameter 1000 mm with U shape steel dampers, 16 U shape steel dampers, 74 elastic sliding dampers (30 with 400 mm diameter, 25 with 600 mm diameter, 11 with 800 mm diameter and 8 with 900 mm diameter). According to the person in charge of the building, up-down shaking happened together with horizontal shaking during earthquake. On the 6th floor, contents inside of the rooms such as refrigerators and shelves were moved or turned over, and the fire protection steel door moved to open and hit against the ceiling by vertical shaking causing the damage to the lamp covers. From the trace on the scratch board in the SI floor, the maximum displacement was estimated around 25 cm in the West direction. This displacement was also confirmed from the trace of movement of the sliding bearing (Figure 7-(b)). The bolts of steel dampers became loose and the paint on the dampers was peeled off widely (Figure 7-(c) and (d)).

(b) Trace of movement of sliding damper

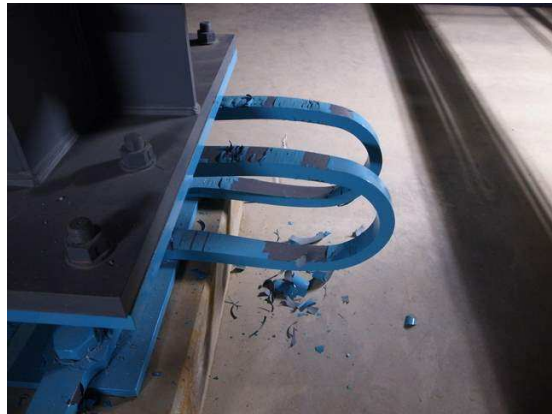
(d) Trace of movement of sliding damper
