# The Performance of Houses in the Canterbury Earthquake Sequence

Graeme J Beattie<sup>1</sup>

## Abstract

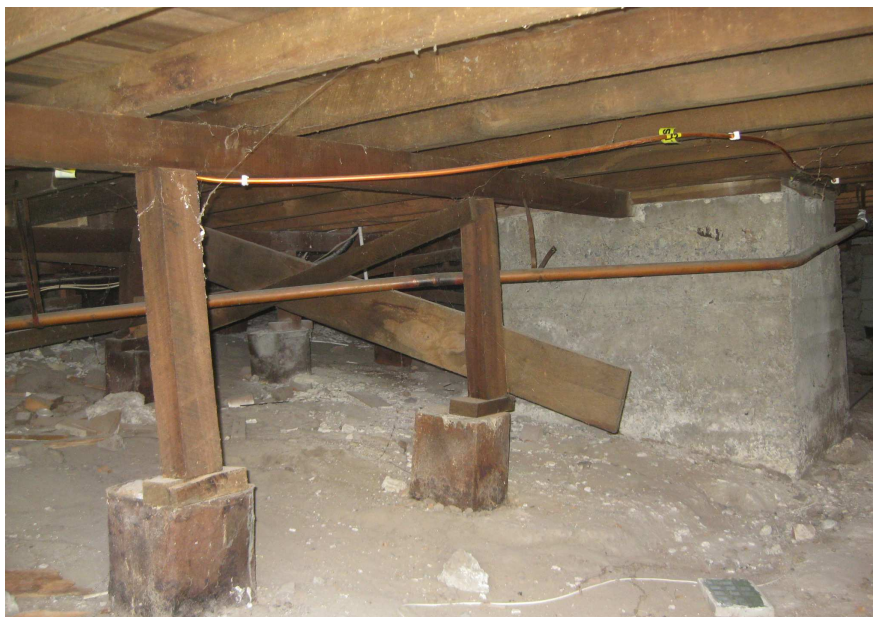
**Figure 1: Jack studs beneath a hillside dwelling (tilt due to superstructure lateral displacement)**

Houses constructed on steeply sloping sites were more badly damaged when the foundation systems were not designed to properly cater for the potential stiffness incompatibility between the short and tall foundations. Similarly, hillside houses built with large windows to make the most of a view often suffered from a stiffness incompatibility between the view facing walls and the walls on the opposite side of the house, resulting in breakage of the windows. The provision of stiffer bracing systems for the view facing walls will serve to lessen these effects.

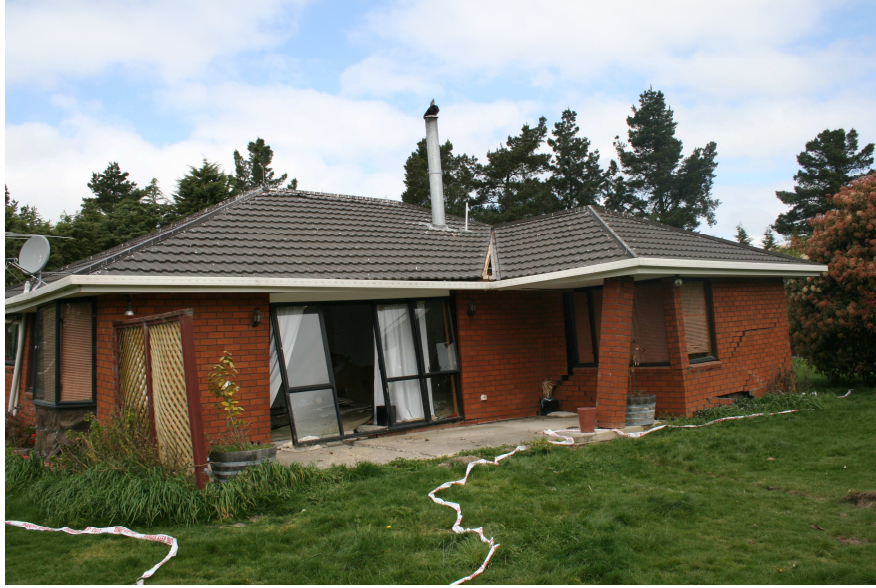
Much of the damage to houses on the flat was due to differential ground settlement and lateral spreading associated with liquefaction and varied from quite minor to major (Figure 2). In houses not affected by ground liquefaction, the most obvious signs of house damage viewed from the outside were failed unreinforced masonry chimneys on older houses and the loss of portions of veneer.

**Figure 2: Severely damaged house from differential ground settlement and lateral spreading**

Houses that were affected by ground distortion from liquefaction were shown to be better protected when a stiff foundation system such as a reinforced waffle slab was used, which could bridge over ground distortions without having excessive curvatures. Houses with heavy claddings clearly distorted more than those with lightweight claddings when the ground beneath them liquefied. Under shaking action alone, heavy houses can be designed to have stronger bracing systems to resist the greater inertial forces.

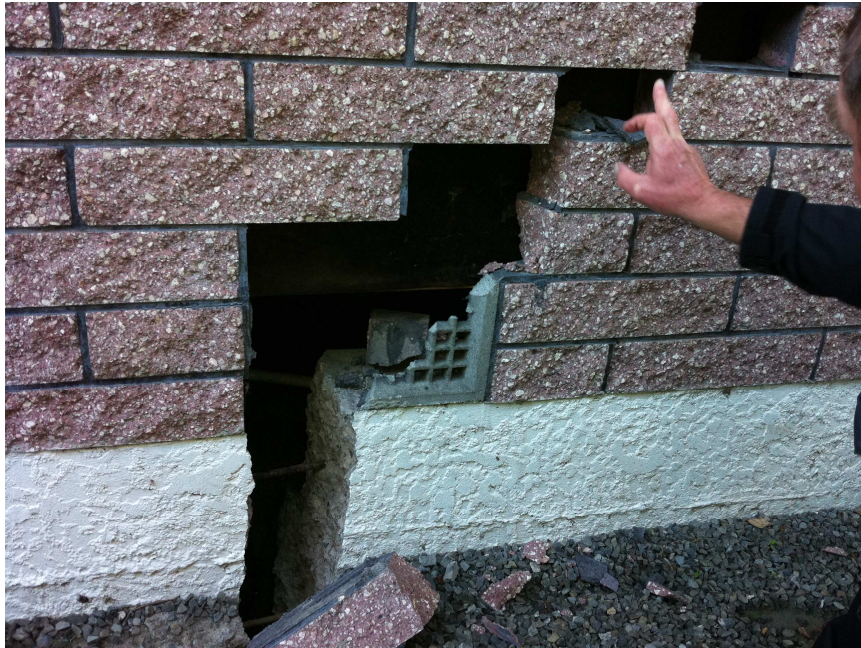
Slab on grade foundations performed well under earthquake shaking. However, ground deformations beneath these slabs, caused either by liquefaction settlement or lateral ground spreading on the flat or ground slumping in the hill suburbs, resulted in sometimes severe distortions of the concrete slabs. Of the surveyed properties, 81 had some evidence of liquefaction. Eighteen of these were slab on grade foundations and 14 were undamaged. The common perimeter concrete foundation with internal piles also fared well under ground shaking but was affected by varying degrees by the ground movement. It was common for these perimeter foundations to be unreinforced in the early to mid 20th century houses but most foundations constructed after this contained at least one 12mm diameter bar, often plain. Whether reinforced in this way or not, these foundations were unable to resist the ground deformations and fractured (Figure 3). Fifty seven of the surveyed properties with perimeter foundations were located where the ground had liquefied and 24 of these were undamaged.

**Figure 3. Example of reinforced concrete perimeter foundation pulled apart by spreading ground**

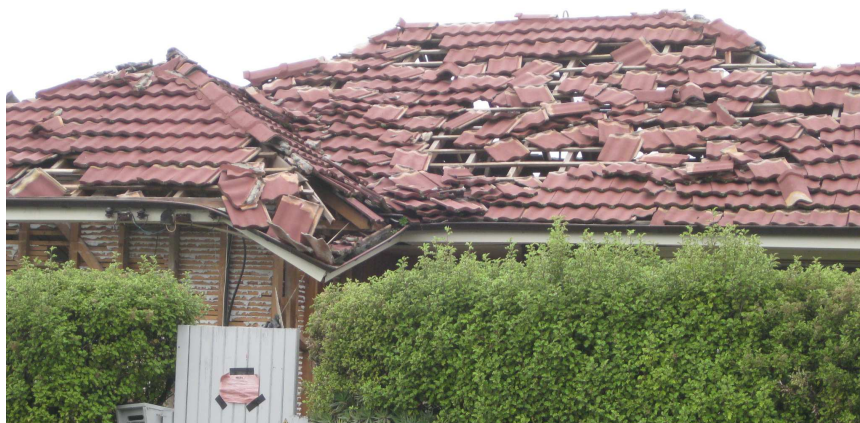
Damage to sheet roof claddings and metal tiles was confined mainly to damage sustained from falling chimneys and tended to be minor. Concrete and clay tile roofs also sustained damage from falling chimneys but those in the hill suburbs often suffered from dislodgement of the tiles from the supporting battens (Figure 4). It was common for such tiles not to be

tied to the framing or for the ties (if they were present) to have corroded. Very high vertical peak ground accelerations (>1g) were recorded in February 2011 in the hill suburbs and this is sure to have contributed to the tile dislodgement.

**Figure 4: Dislodged concrete roof tiles**
