# Post-occupancy Evaluation in Public Buildings

**Keywords: Post-Occupation Evaluation, maintenance of historical buildings, Walk-through assessment.**

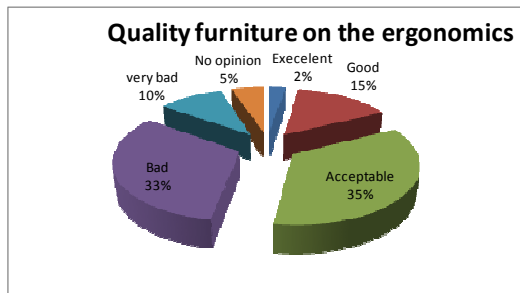
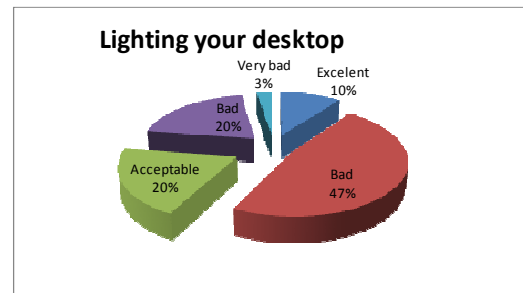
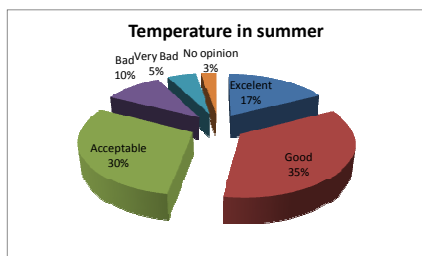
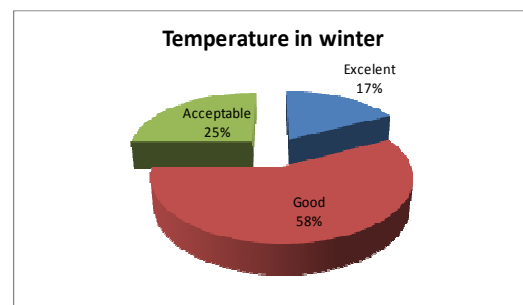
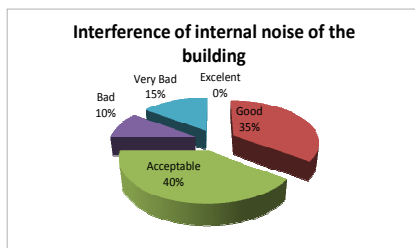
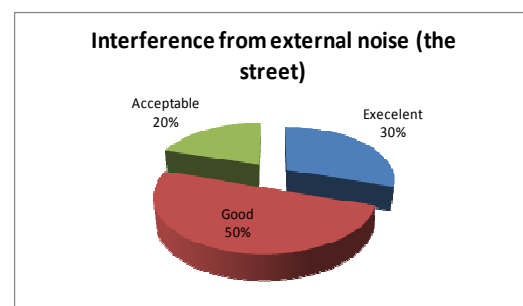
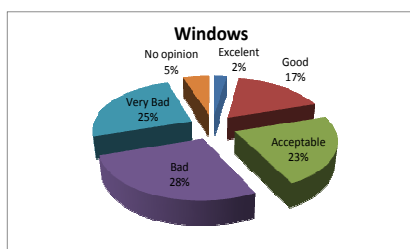
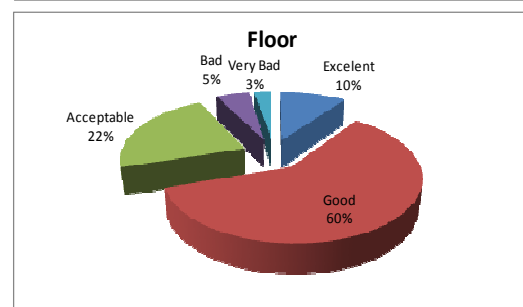
## Feedback from users on the desktop

The graphs above show the level of user satisfaction in the workplace. Due to the lack of standardization of mobile and inappropriate choice as ergonomics, there is a dissatisfaction approximately 83% of respondents. Officials expressed satisfaction about the lighting, especially those who work in environments with a balcony, which allows the use of natural lighting and ventilation. In other environments fluorescent lamps meet the users and provide lower energy consumption. The temperature in summer causes dissatisfaction among users due to the difficulty of distributing the air conditioning system. In winter there is a significant use of natural ventilation as the building has large will enable cross ventilation. The external noises interfere less in the building because of the remoteness of the terrain front, but there is a lack of the use of materials that reduce the noise caused by internal users. Some

windows require maintenance and greater opening to allow air circulation. The floors are in good condition and in some cases needing replacement parts. The dissatisfaction of the users when the restrooms is related to the reuse of the building, since the existing toilets were constructed for hotel use and are not distributed according to actual need.

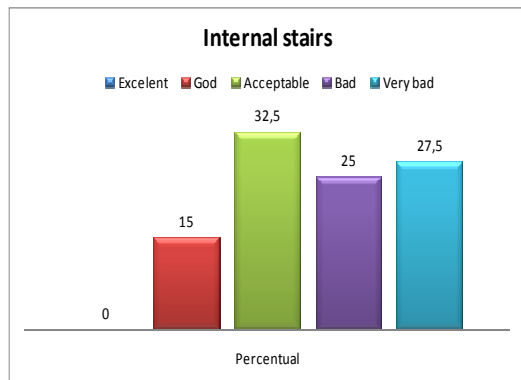
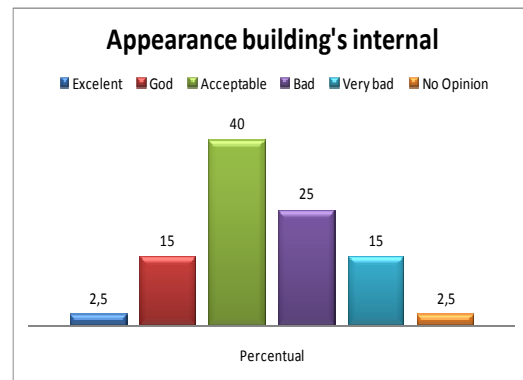
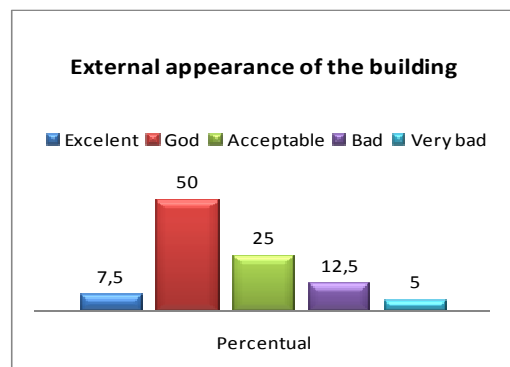
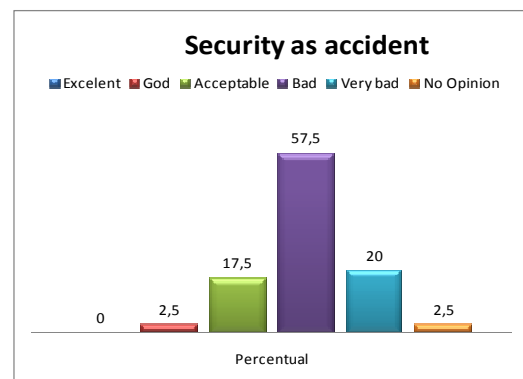
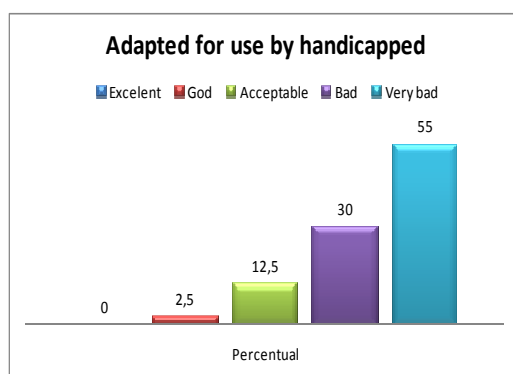
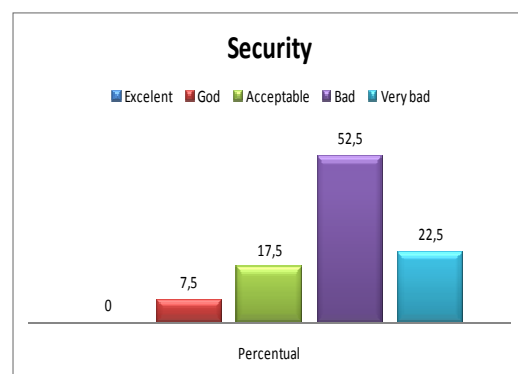
### Opinions on building users

From the graphs it is possible to perceive the dissatisfaction of the users of the building as the signaling and safety as accidents, since the building does not present risk map and a few fire extinguishers. Due to the large influx of people into the building, there is a need to build new ramps and renovate existing ones to meet the special needs and handicapped. The stairs need emergency luminaires and more intense artificial lighting to prevent accidents. Most users satisfaction shows the external appearance of the building which has recently undergone renovations and dissatisfaction with the outward appearance for reasons explained above in evaluations Walk-Through, Quality and Environmental Comfort.
