# Façade Assessment Procedure for the Evaluation of Durability of Existing Buildings

The method has a direct experimental application within the project “Città Studi: Sustainable Campus”, which has the aim to transform the university quarter in Milan into an exemplar campus with respect to life quality and environmental sustainability. In particular the paper will report about the recovery-requalification of existing buildings of Politecnico di Milano at Leonardo Campus, which are nowadays under investigation/study through visual inspections, imaging diagnostic, and especially, IR Thermography. The case study deals with both the issue of repairing and increasing energy efficiency, considering durability and management of buildings, and the cultural issue of preserving masterpieces of the contemporary architecture, since many of the buildings under investigation have the famous architect Giò Ponti as author.

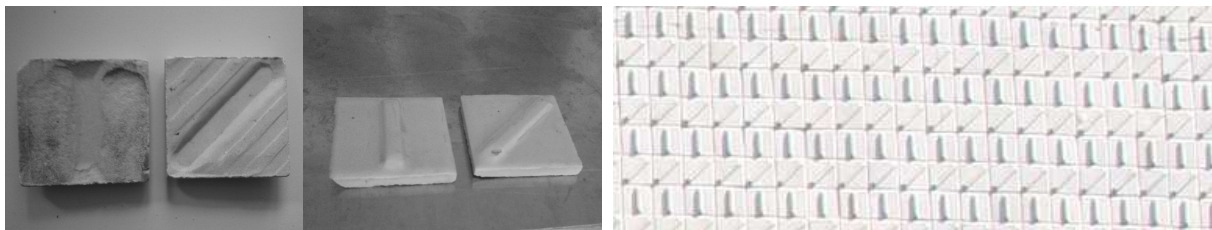
**Figure 2: Building 15 – tiles details**

Building 15, has grey clinker tiles with a vitrified layer on the surface. The tiles are characterized by a small projection 1 cm thick, placed with different inclination in order to create effects of light and shade (*fig. 2*).
