# Seismic safety of places of worship in Italy's Gran Sasso and Monti della Laga National Park

Aurelio Petracca<sup>1</sup>, Carmela Morisi<sup>2</sup>, Giandomenico Cifani<sup>3</sup>, Giovanni Cialone<sup>4</sup>

## Abstract title

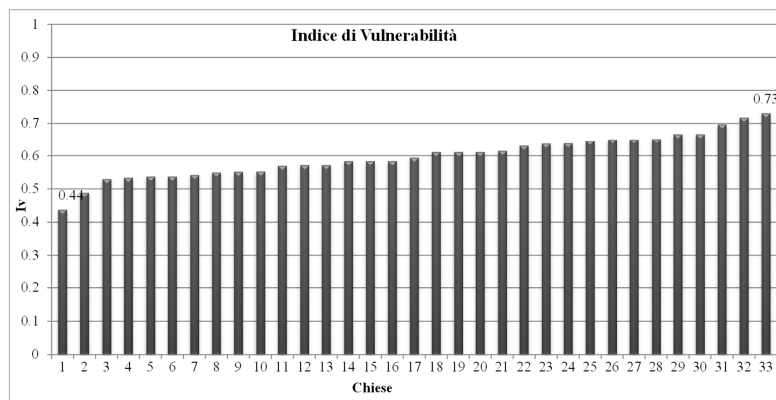
**Figure 5. Vulnerability indices**

In addition, these churches also underwent a data sheet survey using the “Level II churches damage and vulnerability survey sheet”. The survey method is based on identifying 28 possible damage mechanisms affecting a series of the church’s macroelements and analysing the factors that can facilitate or prevent the activation of such mechanisms. The procedure leads to the creation of a vulnerability index  $i_v$  ranging from 0 to 1, using a suitable combination of points awarded to the various seismic vulnerability and protection elements. This index offers comparison of the degree of vulnerability of churches of different shapes and sizes, allowing a sort of hierarchy to be established (see fig. 5).

By assessing the damage mechanisms that can be activated in the presence of a certain macroelement, it can be noted that façade mechanisms are likely in almost all the churches (97%). This shows that the sample is composed of buildings that are either isolated or form part of complexes in which such macroelement can be identified. The highest damage level, and thus mechanism activation, is also found: 24% overturning of façade, 15% top, 27% in-plane mechanisms. The cases noted of overturning are characterised by the presence of vertical cracks on the side walls close to the façade, mainly due to poor bonding between masonry walls. Cracks relating to a mechanism at the top of the façade is almost always due to either the fact that façades project above the top of the roof and are pounded or the thrust of nave vaults. On the other hand, in-plane mechanisms are helped by the presence of various openings in the façade, some of notable size. The greater possibility of activating a

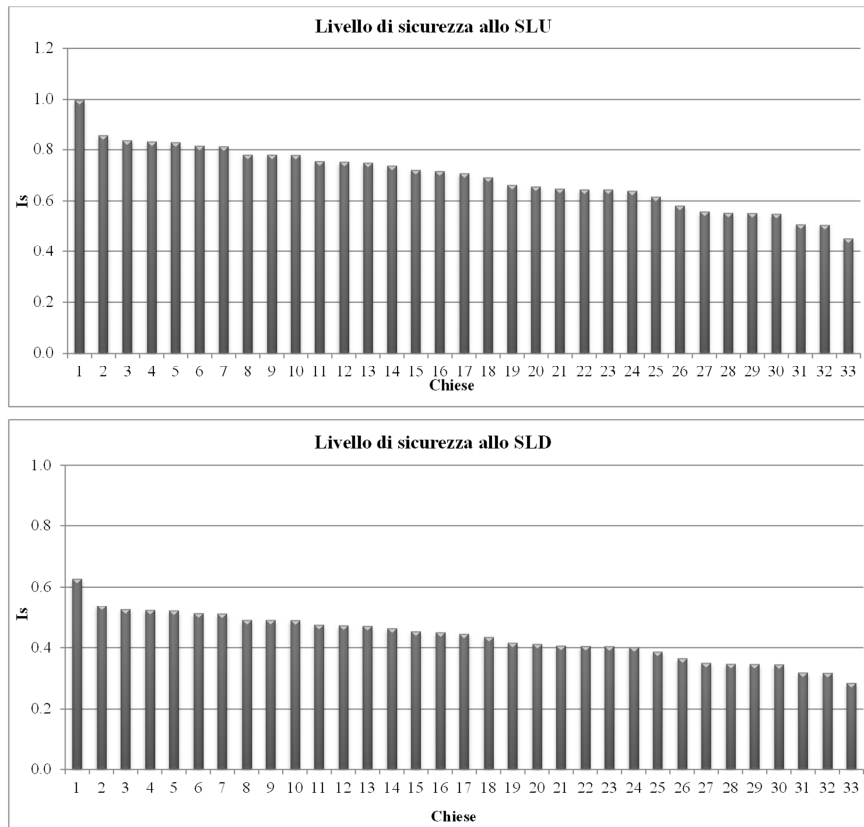
**Figure 9. Safety indices at ULS and DLS**

where:  $a_{ULS}$  is the ground acceleration that will lead to the ultimate limit state being reached;  $S$  is a parameter that takes account of the stratigraphic profile of the underlying subsoil and morphological effects;  $\gamma_1$  is the importance coefficient that takes account of the building’s position and its cultural importance.  $a_g$  is the reference acceleration for the site. This is the same for the Damage Limitation State. This purely statistical approach may be considered correct since it refers to the analysis of a specific area. It allows drawing up of lists of priority and programming of more detailed assessments in the best possible manner with a view to implementing preventive measures. Indeed, the use of a single model for assessments of this type allows more objective comparison as far as seismic risk is concerned. Reference accelerations for the communes in which the places of worship are located were taken from current technical standards. Safety indices at ULS and DLS for the churches in question are given in the following table and graphs (table 3, figure 9).

As confirmation of that previously noted in the case of minor earthquakes, it is worth pointing out that these structures are more susceptible to DLS than ULS. It may be noted that ground acceleration values corresponding to the ultimate limit state (ULS) are fairly high. Indeed, mechanisms will generally be activated at lower values, although higher acceleration levels are needed before causing the structure to collapse.

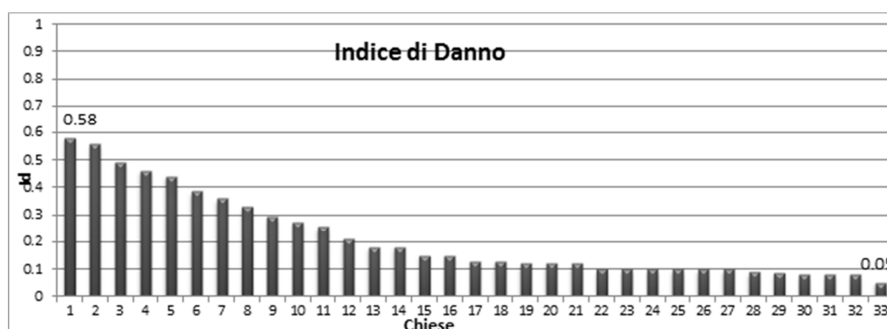
**Figure 12. Damage indices for the sample of churches**

Damage assessment was carried out using the church seismic damage survey sheet that considers the same macroelements and damage mechanisms as the vulnerability survey sheet. The method associated with the survey sheet provides for the calculation of a damage index  $i_d$  (ranging from 0 to 1) representing the church's average damage level (fig. 12).

It can indeed be noted that there is good correspondence between mechanisms deemed more hazardous (see table 8) and those in which the highest damage level was found.
