Thermo-hygrometric and physical-mechanical pathologies of the steel flat roofs: the case of a large industrial plant in Tito (Potenza, Italy).

Thermo-hygrometric and physical-mechanical pathologies of the steel flat roofs - Abstract

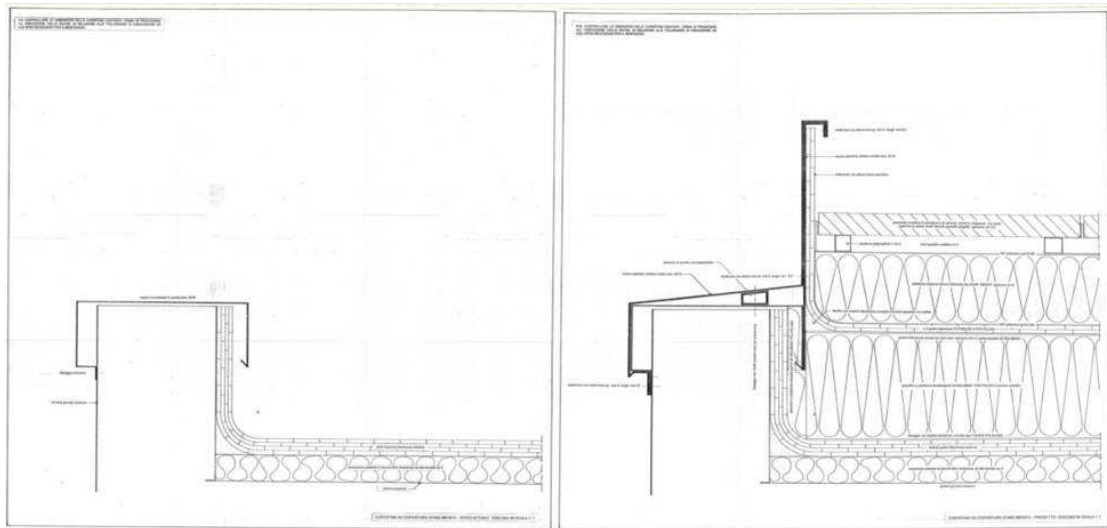
Figure 4: Constructive section of plant covering: on the left, before the retrofit; on the right, after

tensile, elongation and tearing strength), set with the same orientation, half-module staggered, because this sheets, with composite reinforcing layers, have solved problems of older types, which had a higher tensile strength along the length of the sheet, in rapport with the breadth (Figg. 4 and 5).

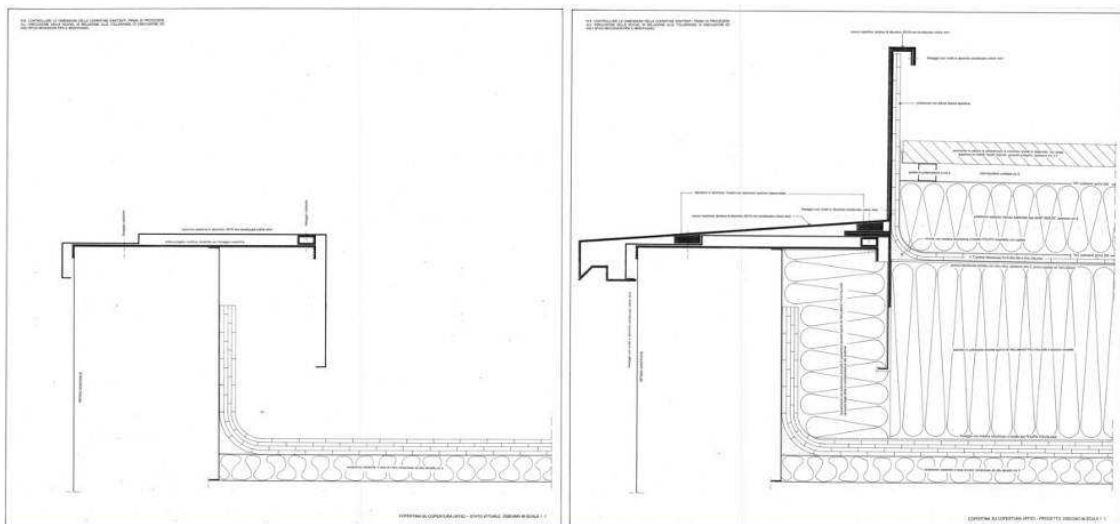
Figure 5: Constructive section of the office covering: to the left, before retrofit; to the right, after

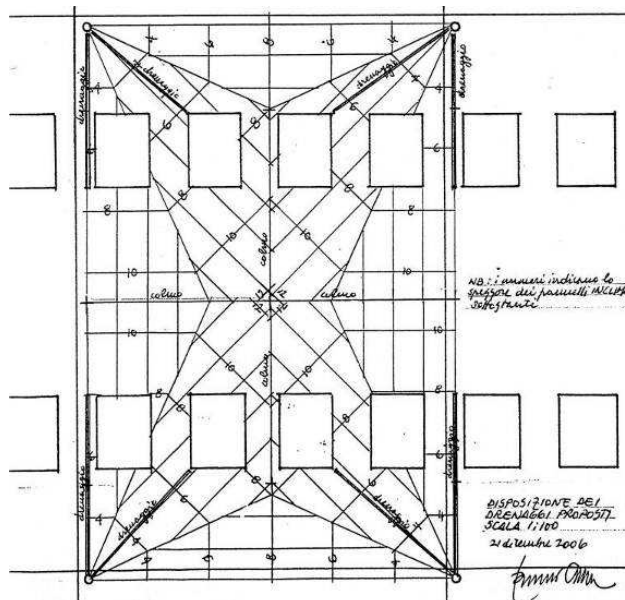
Figure 6: Plan of a typical span of the industrial plant, with drainage grooves added during the work

Meanwhile, evaporation of night condensation water keeps cool and to constant temperature both waterproofing, both coverage below (Picture 14). In the phase of setting XPS insulation there had been some “tropical” downpours, who took to open in the panels some drainage grooves, 4 cm deep, 2 cm wide, who constitute preferential ways for evacuating rainwater (Fig. 6). The result, from the point of view of roof transmittance, has been an upgrade of 10 times: from 1,93 W/(m²K) to 0,185 W/(m²K), with an annual saving in primary energy of 262.197 kWh [MARINO, 2009, pagg.188-230, 298-373].
