Performance of Seismically Isolated Buildings at March 11, 2011, Tohoku Earthquake

The State of the Art of Seismically Isolated Buildings in Japan

2.1 SI building (A)

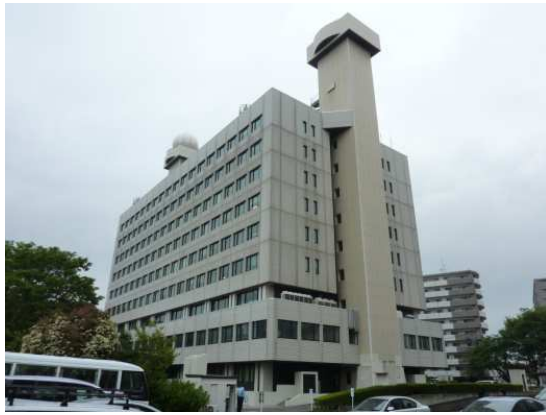
(a) Overview of the building

The SI building (A) is a reinforced concrete office building with 9-story super-structure and 2-story basement, located in Miyagino-ward in Sendai-city (Figure 3-(a)). The building was retrofitted by using base isolation technique putting isolation devices on the top of columns in B1F. The floor plan has the 26.4 m × 54 m rectangular shape and 44 high-damping rubber bearings (HRBs) are installed. At 2011 Tohoku Earthquake, no furniture was turned over and no structural damage was observed. However, some damage was observed at the cover-panels of fire protection and the expansion joints near the boundary between isolated and non-isolated floors (Figure 3-(b)). It seems that parts of expansion joints were not well operated due to the large displacement of SI floor during earthquake. This building has accelerometers at B2F, 1F and 9F (top floor). Also, there is an accelerometer installed by JMA in the basement of an adjacent building. The maximum acceleration values of these accelerometers at the main shock of 2011 Tohoku Earthquake are listed in Table 2.

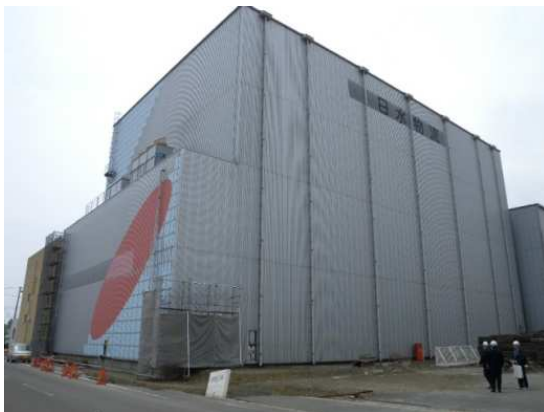
(a) Overview of the building

The SI building (B) is a one-story steel warehouse constructed in 1996, located in Miyaginoward in Sendai-city (Figure 4-(a)). The building height is 30 m. There are 20 HRBs (with diameter 850 mm) and 4 HRBs (with diameter 800 mm) arranged in the basement with 51.6 m × 31.7 m rectangular shape. Since the building is located near the Sendai-Shiogama bay, Tsunami reached the building and the SI floor was submerged under water. Since this warehouse is a freezer, water entered in the freezer space was frozen after the earthquake. Also it took 16 days to remove the water from the SI floor. No damage to the building was observed. Also, from visual inspection, there was no harmful scratch or inflation of the rubber of HRB, however, severe rust was observed at the steel plates and bolts (Figure 4-(b)).

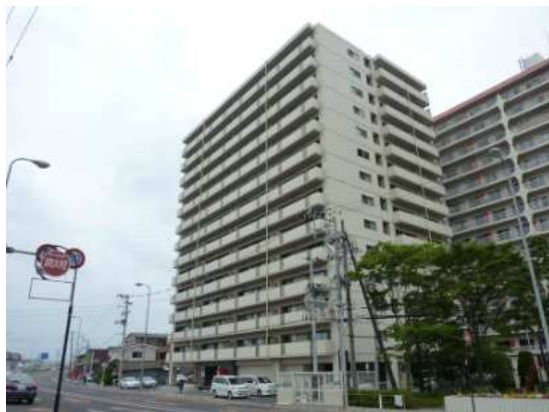
(a) Overview of the building

The SI building (C) is a 14-story reinforced concrete building used for condominium, located in Miyagino-ward in Sendai-city (Figure 5-(a)). The building has the U-shape plan and the corners of the building are separated by expansion joints. There are 24 NRBs, 8 Lead dampers, and 13 U-shape steel dampers installed in the SI floor. According to the owner of the building, no furniture was turned over and no structural damage was observed inside of rooms after the earthquake. Also no damage was found to NRBs by visual inspection; however, paint of U-shape dampers was peeled off (Figure 5-(b)) and many cracks were found on Lead dampers (Figure 5-(c)).

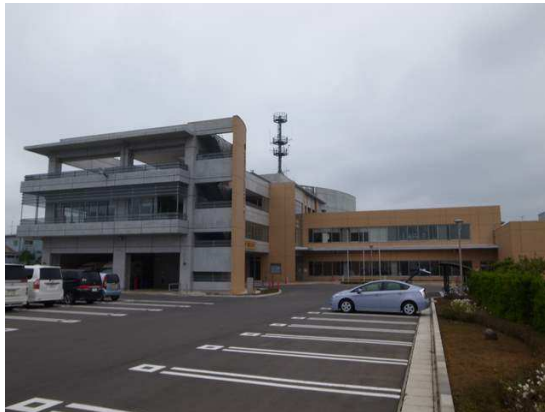
(a) Overview of the building

The SI building (L) is a 3-story reinforced concrete building used for firehouse, located in Tome-city (Figure 6-(a)). The following SI devices are installed in the basement with L-shape plan; 61 m in the East-West direction and 58 m in the North-South direction: 34 lead rubber

bearings (LRB) (6 with diameter 650 mm and 28 with diameter 700 mm) , 11 elastic-sliding bearings (6 with diameter 500 mm and 5 with diameter 600 mm), and 8 U-shape steel dampers. a) According to the person in charge of the building, no furniture was turned over and no structural damage was observed. However, because of the movement of SI floor during earthquake, the bolts of steel dampers became loose and the paint on the dampers was peeled off widely. Also a large amount of residual deformation of steel was remained (Figure 6-(b)).

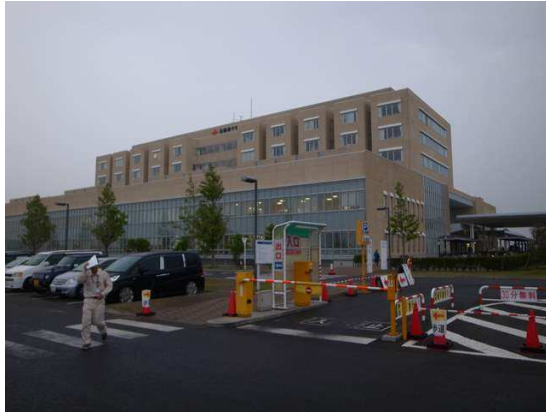
(a) Overview of the building

The SI building (M) is a 6 story steel building with one story basement used for hospital, located in Ishinomaki-city (Figure 7-(a)). Lower part of the building up to second story has the 100 m × 100 m square plan and higher part has 100 m × 25 m plan.

The following SI devices are installed in the basement: 6 natural rubber bearings (NRB) with diameter 1000 mm, 16 laminated rubber bearings with diameter 1000 mm with U shape steel dampers, 16 U shape steel dampers, 74 elastic sliding dampers (30 with 400 mm diameter, 25 with 600 mm diameter, 11 with 800 mm diameter and 8 with 900 mm diameter). According to the person in charge of the building, up-down shaking happened together with horizontal shaking during earthquake. On the 6th floor, contents inside of the rooms such as refrigerators and shelves were moved or turned over, and the fire protection steel door moved to open and hit against the ceiling by vertical shaking causing the damage to the lamp covers. From the trace on the scratch board in the SI floor, the maximum displacement was estimated around 25 cm in the West direction. This displacement was also confirmed from the trace of movement of the sliding bearing (Figure 7-(b)). The bolts of steel dampers became loose and the paint on the dampers was peeled off widely (Figure 7-(c) and (d)).
