Factors Threatening the Cultural Heritage- the Windows of Europe

Paul Dettwiler¹

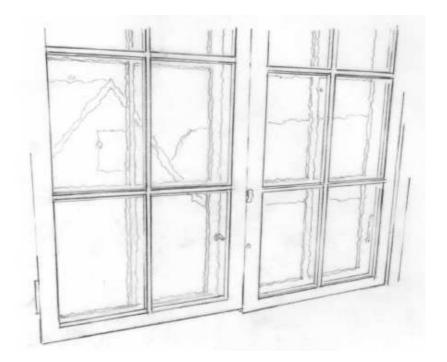
Figure 1. Details and Texture of old windows do not exist in modern windows:

Original Window 18th century, Skottbergska Gården, Karlshamn, Sweden

The concept of "Nordic Light" is related to early skills of milling appropriate profiles of timber of the interiors in order to optimise the daylight in morning and evenings and has thus a functional role apart from the decorative appearance. The timber profiles together with composition of multiple uneven glass panes enable daylight to enter a building smoothly without sharp contrasts that occur between shadow and light. The handicraft of windows of traditional windows consists furthermore of elaborated details of metal: fittings, hinges, catches and handles (e.g. Figure 1). All mentioned materials compose together a characteristic element of the architecture of a façade, and are consequently utmost significant for our cultural heritage.

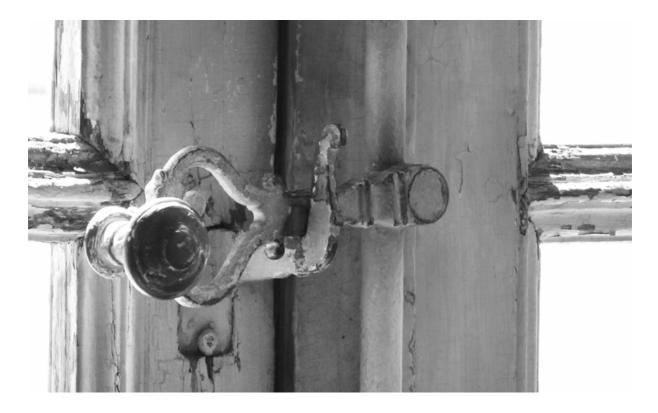
Figure 2. Details and Texture of old windows do not exist in modern windows: Original Window from 17th century, Dijon, France

The character of a building in relation to an urban context must be paid better attention where details such as Figure 2 that render historical traces have great significance for the architectural understanding and historic traceability (Schönbeck, 1994).

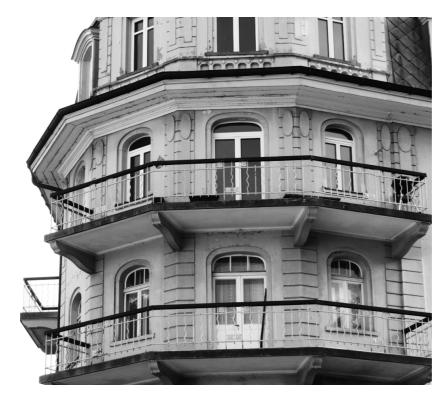
Figure 3. A residential building from beginning last century in Davos, Switzerland where the upper floors have changed to new windows, whereas the lower floor has maintained the original windows.

In this paper it is argued to divide the management old windows into two categories: (1). Buildings where the windows earlier have been replaced one or several times (medieval to 19th century) and (2) Buildings where façades and windows have the same age like Figure 3 (frequent example, houses from 1870, art nouveau buildings from beginning of 20th century). According to "The Venice Charter 1964" a new window might have its place in a historical building that have changed the character of the façade throughout the centuries and where the existing windows have little historical and cultural value. The second category however deals with historical buildings where a considerable part of the original surface is threatened; if possible it would have high value if the entire building to a maximum can maintain its original materials. Nypan (2009) compares short life cycle of modern windows and maintenance of old windows; thus put to question the necessity of a change. Dettwiler (2012) conclude that changes often occur without a rational reason and often the change per se can be of nuisance. An example are the art nouveau buildings in Eastern Germany that after the opening 1989 were renovated for symbolic reasons; having now lost their original windows the buildings must probably already have their second generation of plastic windows.

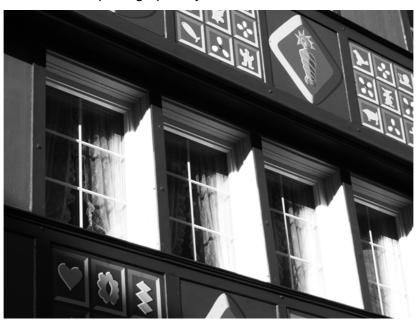
Figure 4. A residential building from 17th in Appenzell, Switzerland after a "Sanierung" with a new coat of paint and new windows (NB. Plastic bars, without function, behind a single glass pane)

Furthermore; houses from 15th century until 19th century that are renovated (German: "Sanierung", literarily translated "Cleansing") in Switzerland often got a new perfect facade with new layers of paint and new windows whereas more prudence can be seen concerning old houses in neighbouring countries with lower GDP. During the 1960s the Swedish word
